## Addendum 03

**Project:** CATA Renovation at 511 S Washington Ave, Lansing, MI 48933

## ROOF CORE INSPECTION REPORT

June 2026

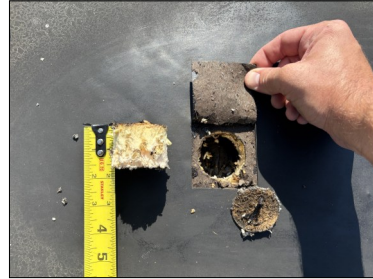
**C-01**

Metal deck  
Vapor barrier  
1.5" polyiso  
Fully adhered EPDM

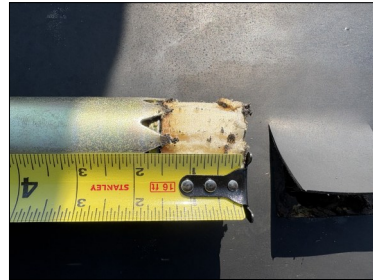
**C-02**

Metal deck  
Vapor barrier  
1.5" polyiso  
Fully adhered EPDM

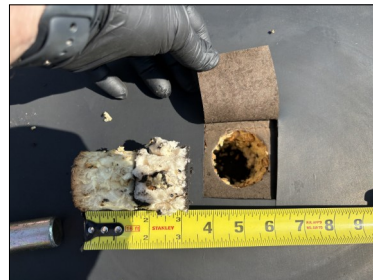
**C-03**

Metal deck  
Vapor barrier  
1.25" polyiso (tapered)  
1.5" polyiso  
Fully adhered EPDM

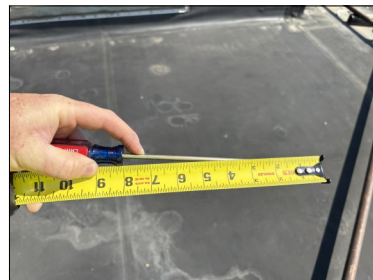
**C-04**

Metal deck (*assumed*)  
Vapor barrier (*assumed*)  
7.0" polyiso (tapered)  
Fully adhered EPDM

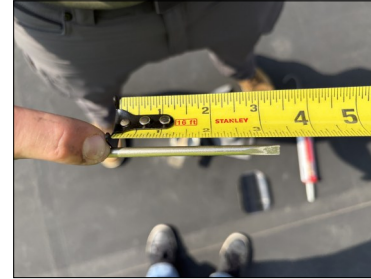
**C-05**

Metal deck (*assumed*)  
Vapor barrier (*assumed*)  
3.25" polyiso (tapered)  
Fully adhered EPDM

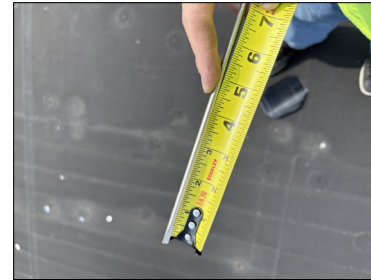
**C-06**

Metal deck (*assumed*)  
Vapor barrier (*assumed*)  
4.5" polyiso (tapered)  
Fully adhered EPDM

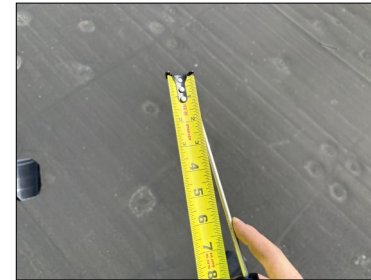
**C-07**

Metal deck (*assumed*)  
Vapor barrier (*assumed*)  
5.75" polyiso (tapered)  
Fully adhered EPDM

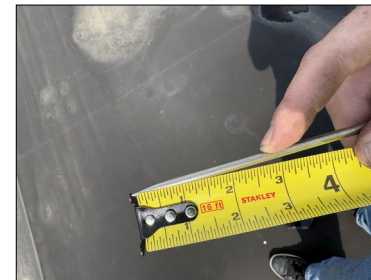
**C-08**

Metal deck (*assumed*)  
Vapor barrier (*assumed*)  
2.75" polyiso (tapered)  
Fully adhered EPDM
